# Cleaning and passivation trial report

| TRIAL NUMBER<br>T-2630-C | DATE<br>6 June 2023 | CUSTOMER<br>Withheld | CONDUCTED BY<br>Misonics |

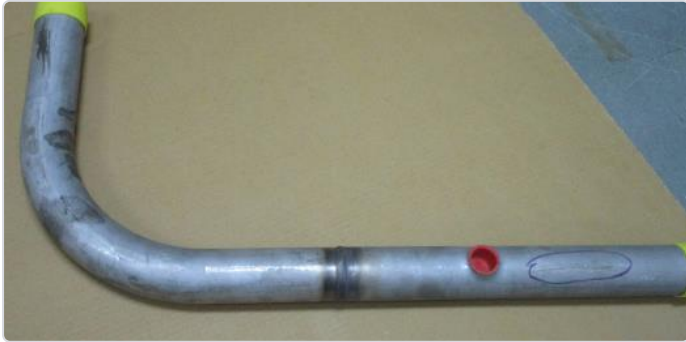
| No. | Part | Material | Geometry | Contamination |
|---|---|---|---|---|
| 1 | Stainless steel pipe | Stainless steel | Smooth surface | Weld marks, carbon |

Stainless steel pipe before

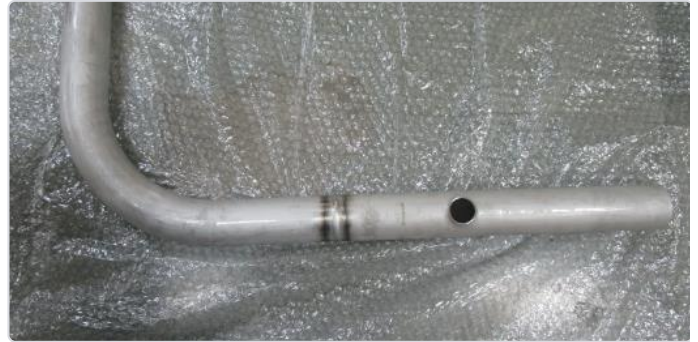
Stainless steel pipe after

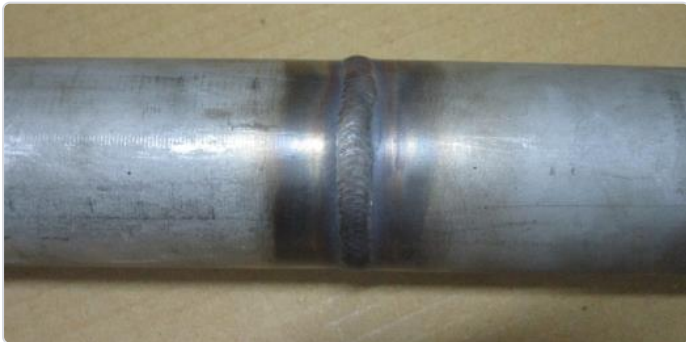
Stainless steel weld before

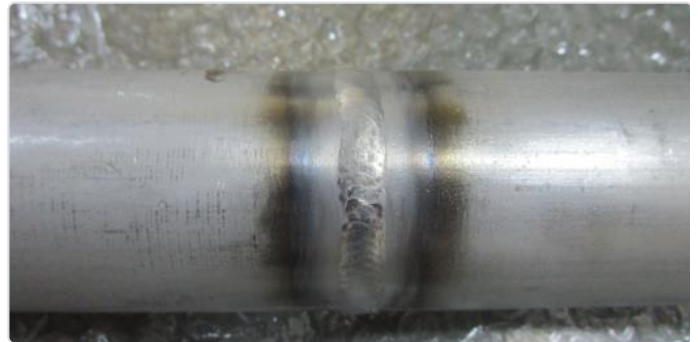
Stainless steel weld after

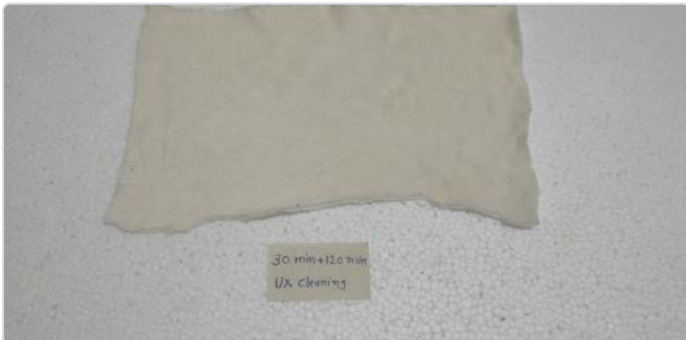
Ferroxyl swab, before cleaning

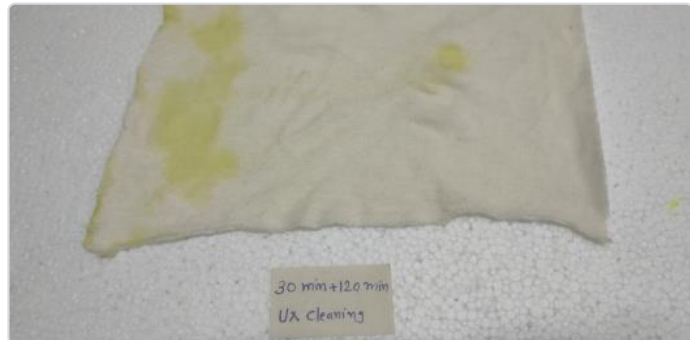
**Result:** **Ferroxyl test: OK**

Ferroxyl swab, after cleaning and passivation

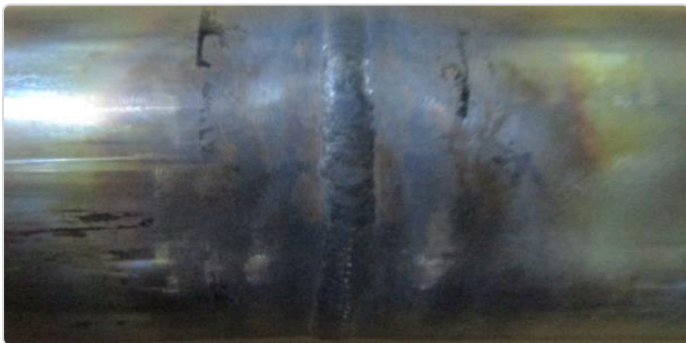
| No. | Part | Material | Geometry | Contamination |
|---|---|---|---|---|
| 3 | Cupronickel pipe | Copper-nickel | Smooth surface | Weld marks, dust |

Cupronickel weld before

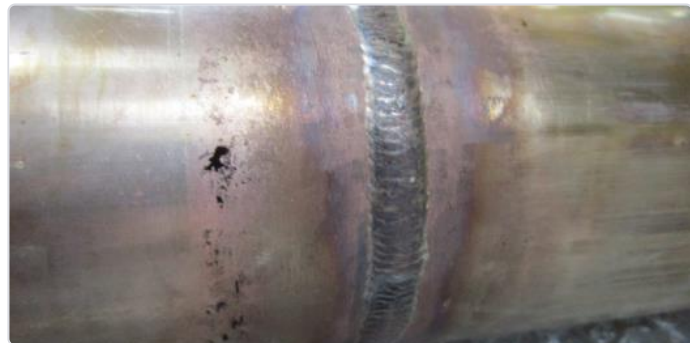
Cupronickel weld after

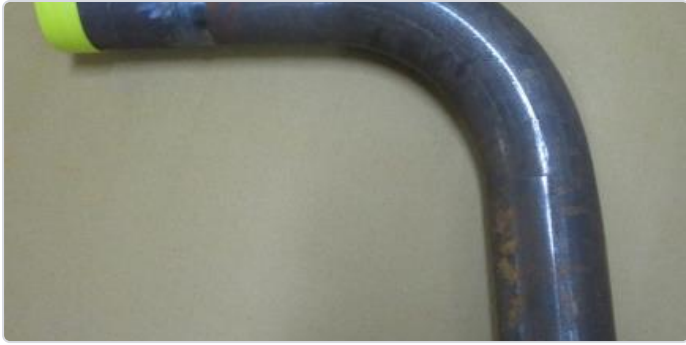
| No. | Part | Material | Geometry | Contamination |
|---|---|---|---|---|
| 2 | Mild steel pipe | Mild steel | Smooth surface | Weld marks, carbon, rust |

Mild steel elbow before

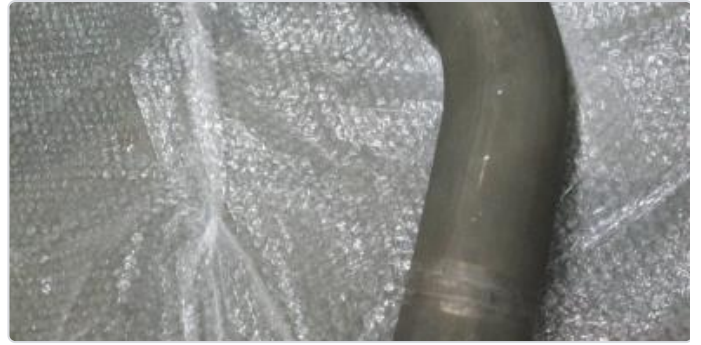
Mild steel elbow after

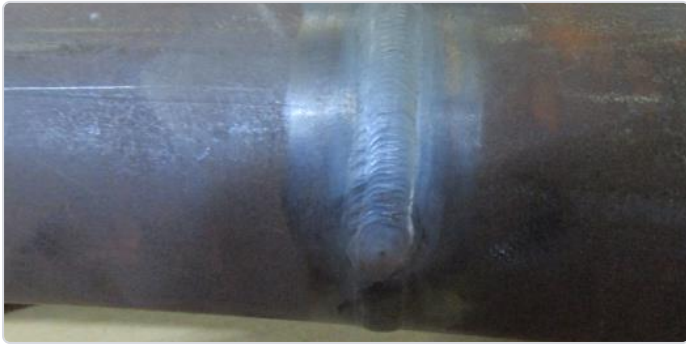
Mild steel weld before

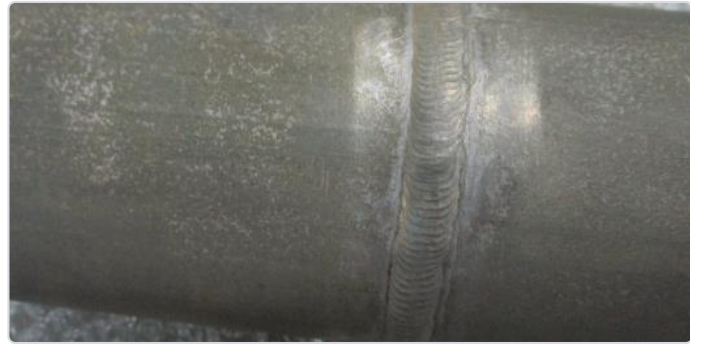
Mild steel weld after

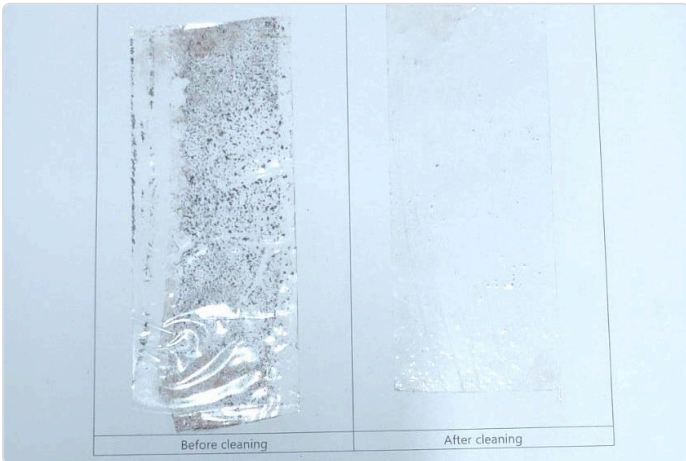
**Result:** **Visually OK · tape test OK****4. REMARKS**

Tape test on the mild steel part: before and after cleaning
